Manhole Inspection Summary

Manhole # S39AA_006MH

Insp Date: **11/14/08 10:22 AM**

Location Address: **Ensor St**

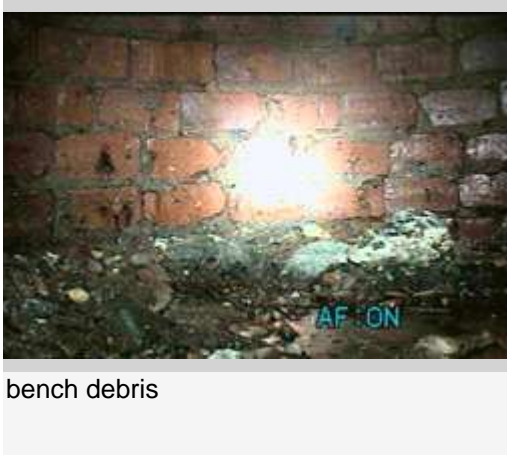
Miscellaneous

bench debris

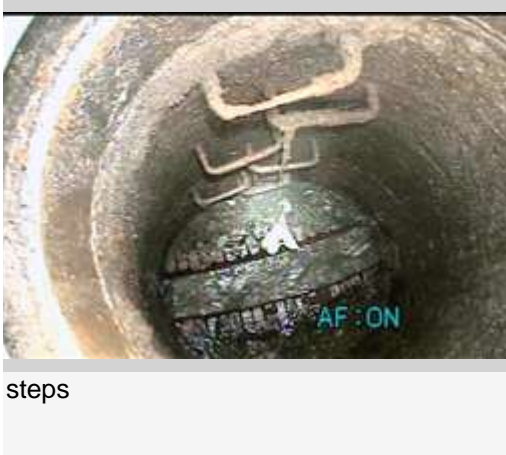
Defect 1

Steps Count: **6** Missing: **0** ☒ **Corroded**

steps

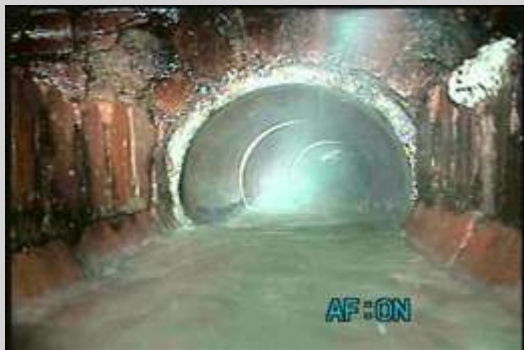
12 O'Clock Outflow

10 in. Circular Gravity Sewer
Pipe Out @ 12 O'Clock

Invert Depth: **9.66** (ft.) Flow Characteristics: **Fast**

Deposits: ☒ None ☐ Mud ☐ Sludge ☐ Debris ☐ Grease

Infiltration: **None** Pipe Seal Cond: **Unknown**

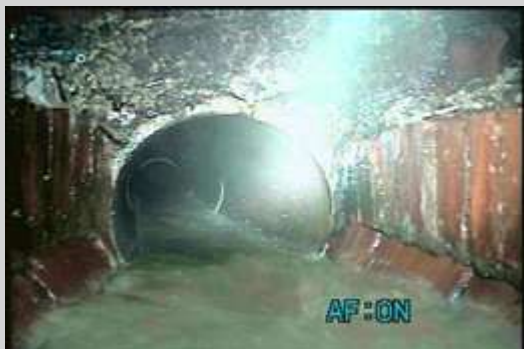
6 O'Clock Inflow

10 in. Circular Gravity Sewer
Pipe In @ 6 O'Clock

Invert Depth: **9.50** (ft.) Flow Characteristics: **Fast**

Deposits: ☒ None ☐ Mud ☐ Sludge ☐ Debris ☐ Grease

Infiltration: **None** Pipe Seal Cond: **Unknown**
